**Schnittzeichnung ProfilGate® aqua**

**Sectional drawing ProfilGate® aqua**

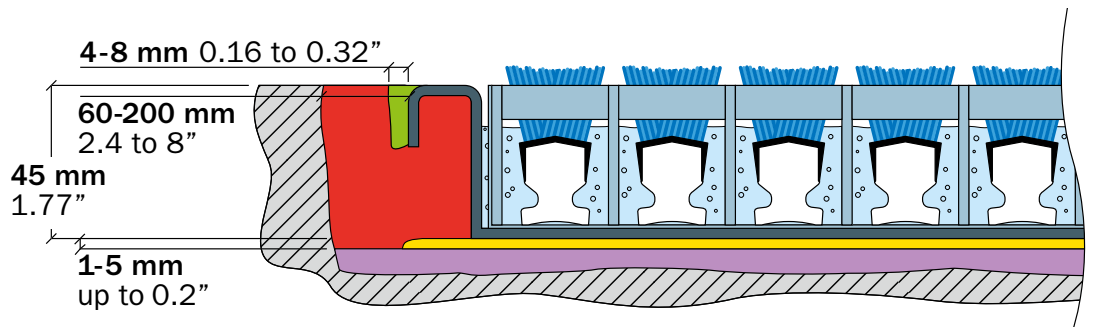
**ProfilGate®
i45 aqua
sti45 aqua
TYP1**

| <p> Wanne V2A

Stainless-steel tray
Cubeta en inox</p> | <p>

Füller/Kleber 1-5mm unter der Wanne
Filling/adhesive 1-5mm / up to 0.2" under the tray
Relleno/pegamento 1-5mm debajo de la cubeta</p> | <p>

Wartungsfuge 4-8 mm Polyurethan
Maintenance joint 4-8 mm polyurethane
Junta de mantenimiento 4-8 mm poliuretano</p> |

| <p> Fugenfüllung 60-200 mm rings um das gesamte Reinigungsfeld (Außenrand)

Joint filling 60-200 mm / 2.4 to 8" – around the whole cleaning field (outer edge)
Relleno junta 60-200 mm alrededor de toda la banda de limpieza (borde exterior)</p> | <p>

Ausgleichsmasse
Levelling compound
Mortero autonivelante</p> | |

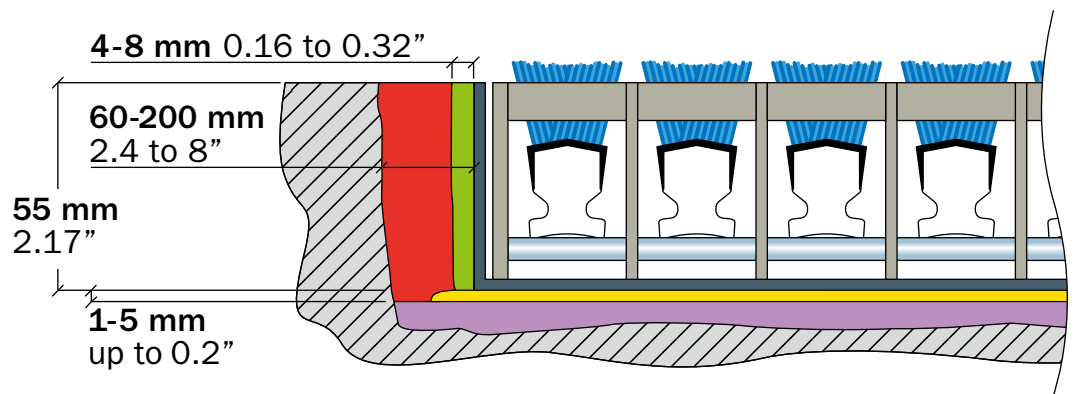
ProfilGate®
b55 / b55 go
i55 / i55 go
k55
st55 / st55 go
sti55 / sti55 go

| Wanne V2A

Stainless-steel tray
Cubeta en inox |

Füller/Kleber 1-5mm unter der Wanne
Filling/adhesive 1-5mm / up to 0.2" under the tray
Relleno/pegamento 1-5mm debajo de la cubeta |

Wartungsfuge 4-8 mm Polyurethan
Maintenance joint 4-8 mm polyurethane
Junta de mantenimiento 4-8 mm poliuretano |

| Fugenfüllung 60-200 mm rings um das gesamte Reinigungsfeld (Außenrand)

Joint filling 60-200 mm / 2.4 to 8" – around the whole cleaning field (outer edge)
Relleno junta 60-200 mm alrededor de toda la banda de limpieza (borde exterior) | |

Ausgleichsmasse
Levelling compound
Mortero autonivelante |
